ARMY CONCEPT TEAM IN VIETNAM
APO 96243

20 DEC 1966

SUBJECT: Final Report of Cartridge, 40mm, WP,
XM-574, ACTIV Project Number AAD 9/67

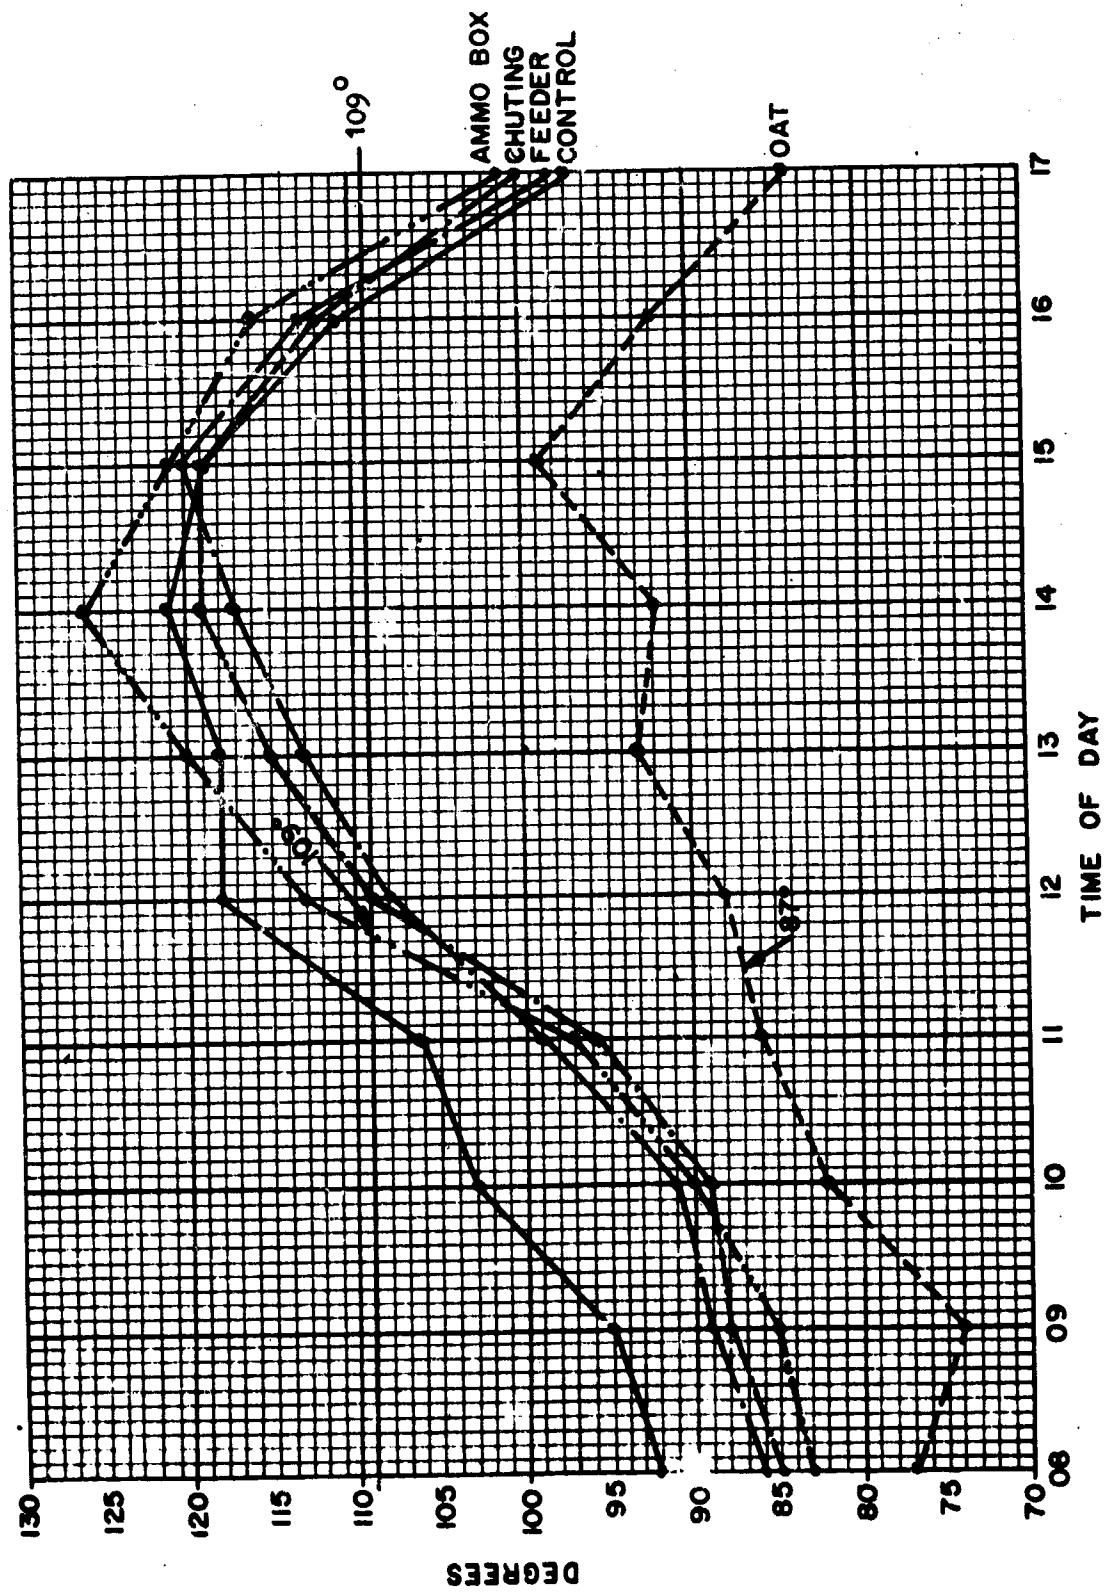
d. With helicopter doors and windows closed, temperatures in the chuting, turret, and ammunition box of the M-5 system ranged from 3° F to 38° F higher than the OAT. Plotted graphs (Inclosures 17 through 20) show that the critical temperature of 109° F was reached in the M-5 system when the OAT guage registered as low as 87° F. The lowest recorded free air temperature at which the OAT reached 87° F and some portion of the M-5 system reached 109° F was 82° F.

M-5 System Temperatures, 2 Sep 66, Doors and Windows Closed

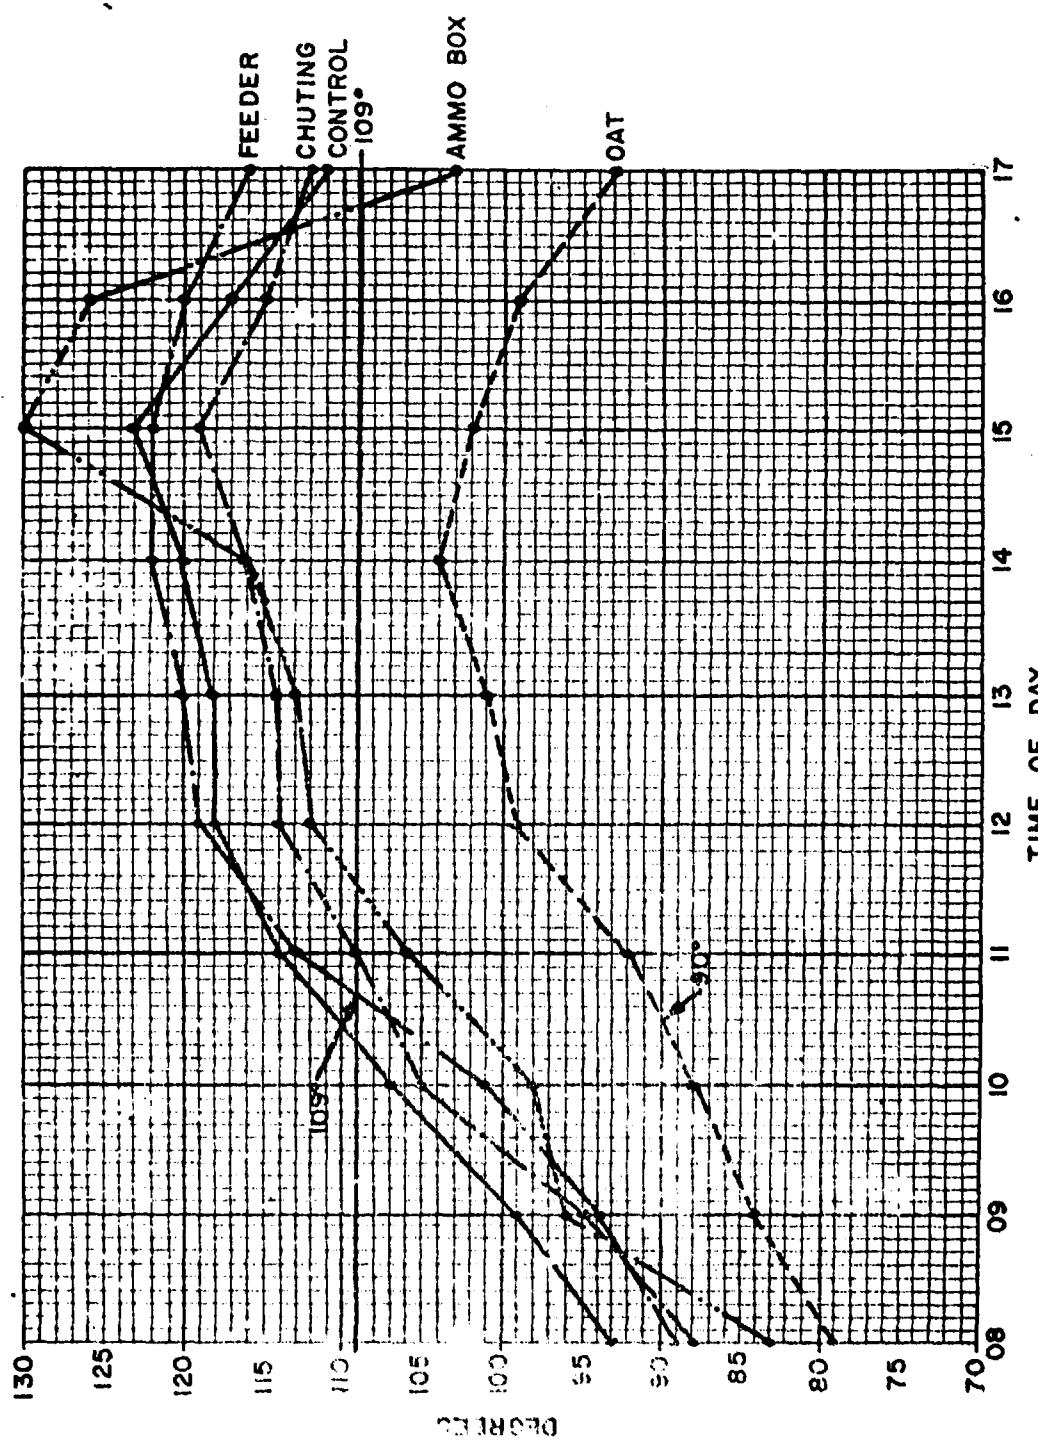
Incl 19

M-5 System Temperatures, 9 Sep 66, Doors and Windows Closed

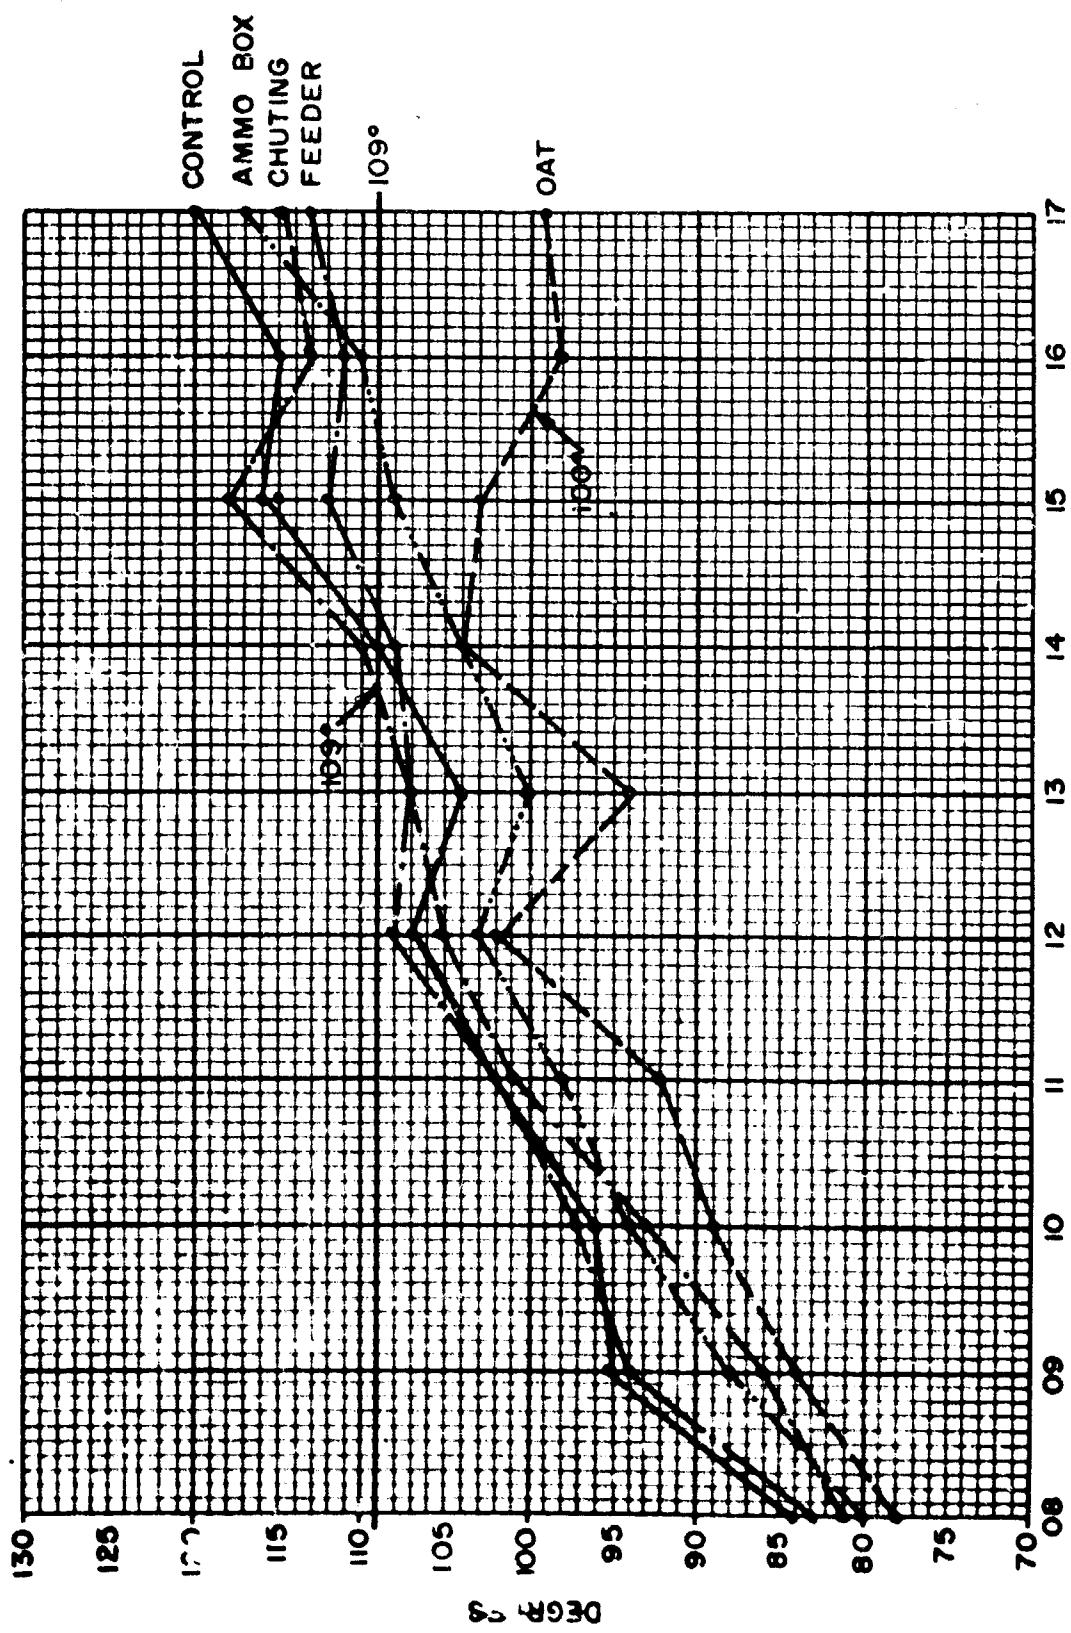
e. In a UH-1B helicopter with the doors and windows open, there was no instance of the M-5 system temperature exceeding 109° F until the OAT reached 92° F. (See inclosures 21 thru 23.)

H-5 System Temperatures, 29 Aug 66, Doors and Windows Open (intermittent rain all day) Incl 21

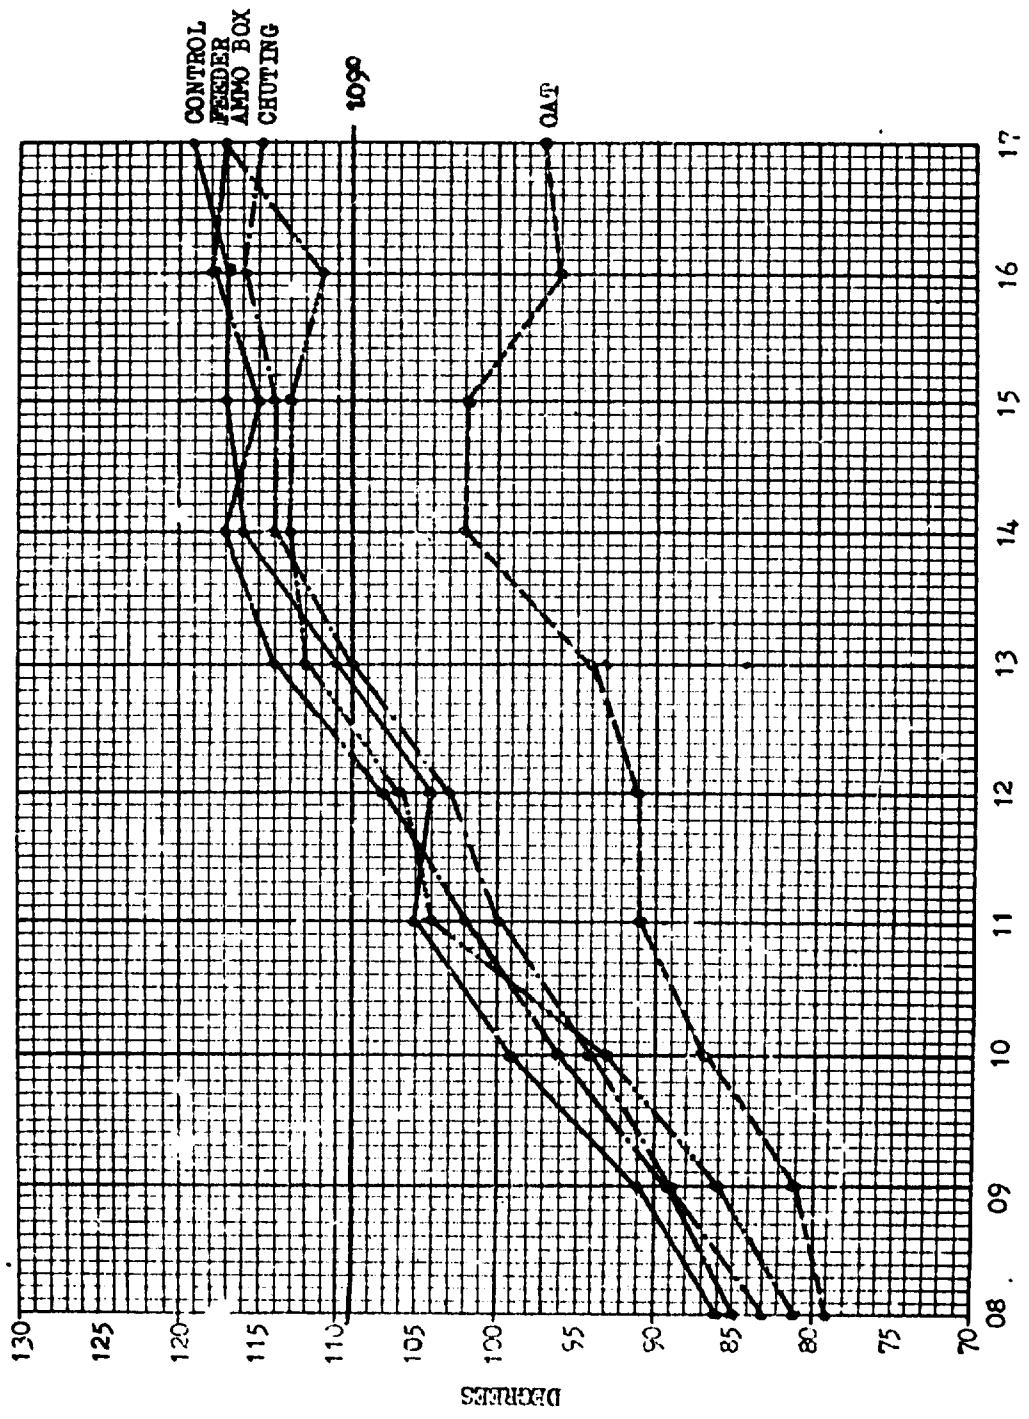
M-5 System Temperatures, 6 Sep 66, Doors and Windows Open

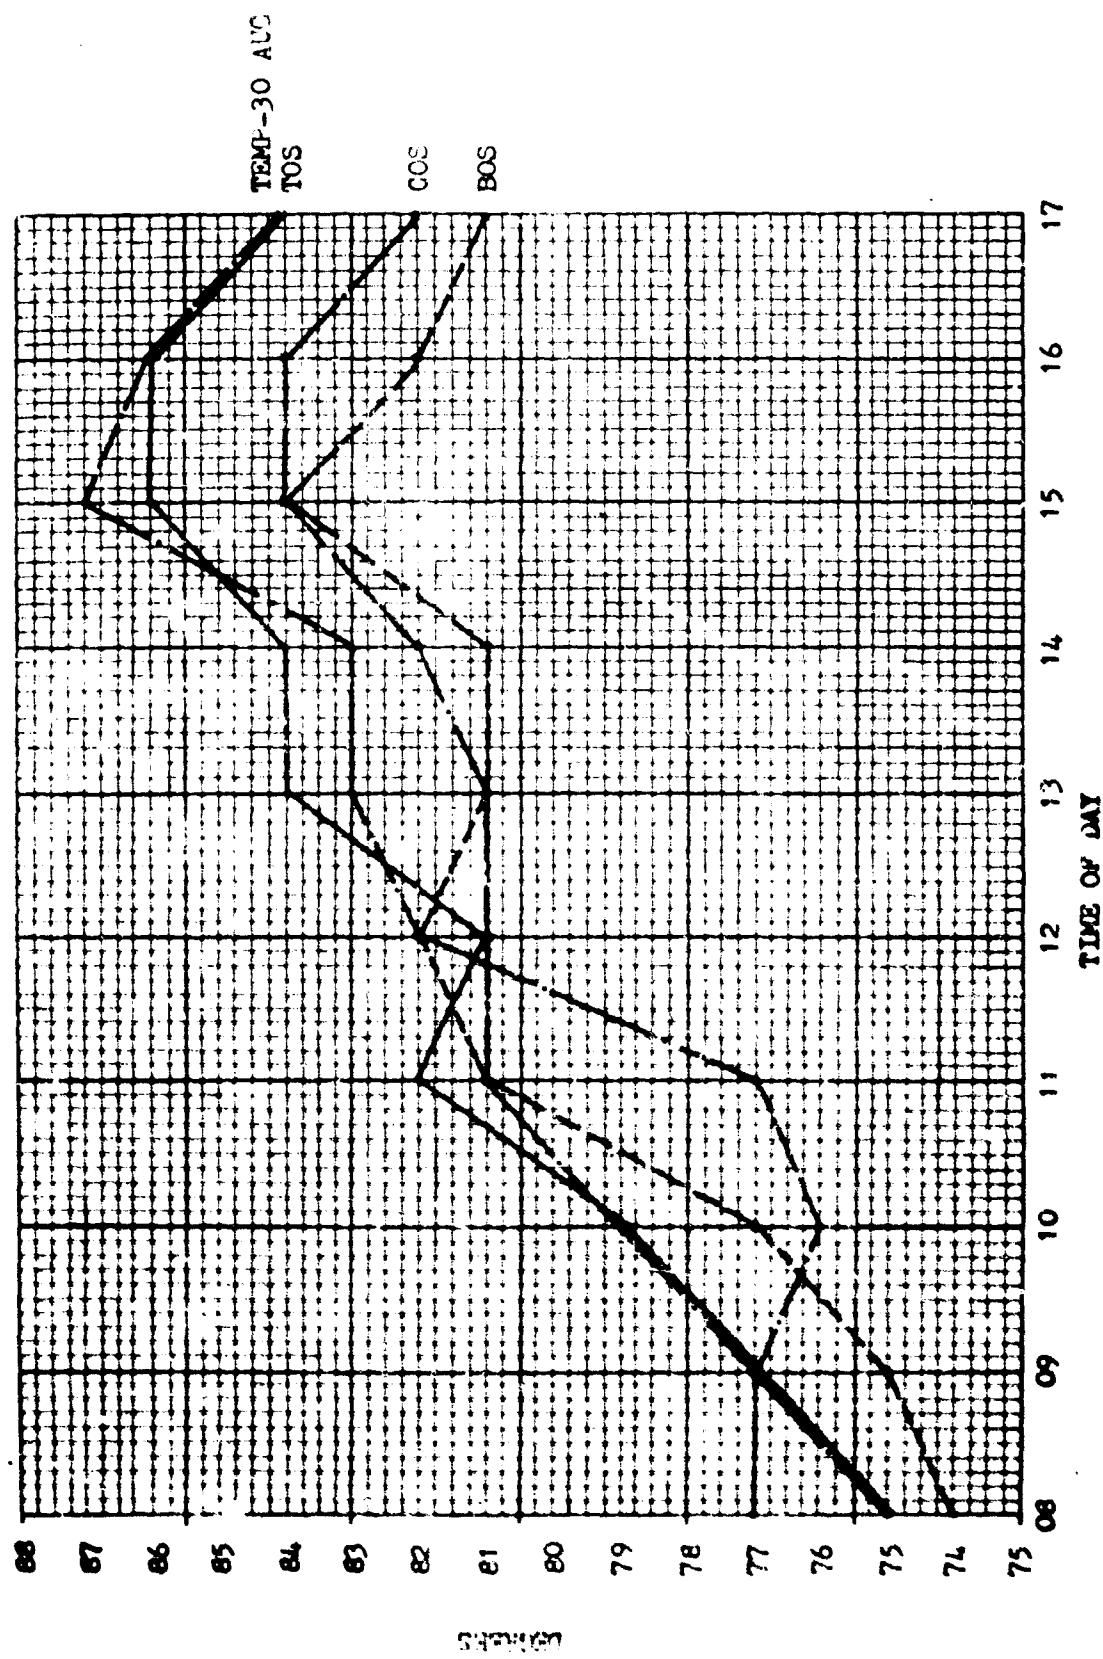
Ammunition Storage Area Temperatures, 29 Aug 66, Bien Hoa

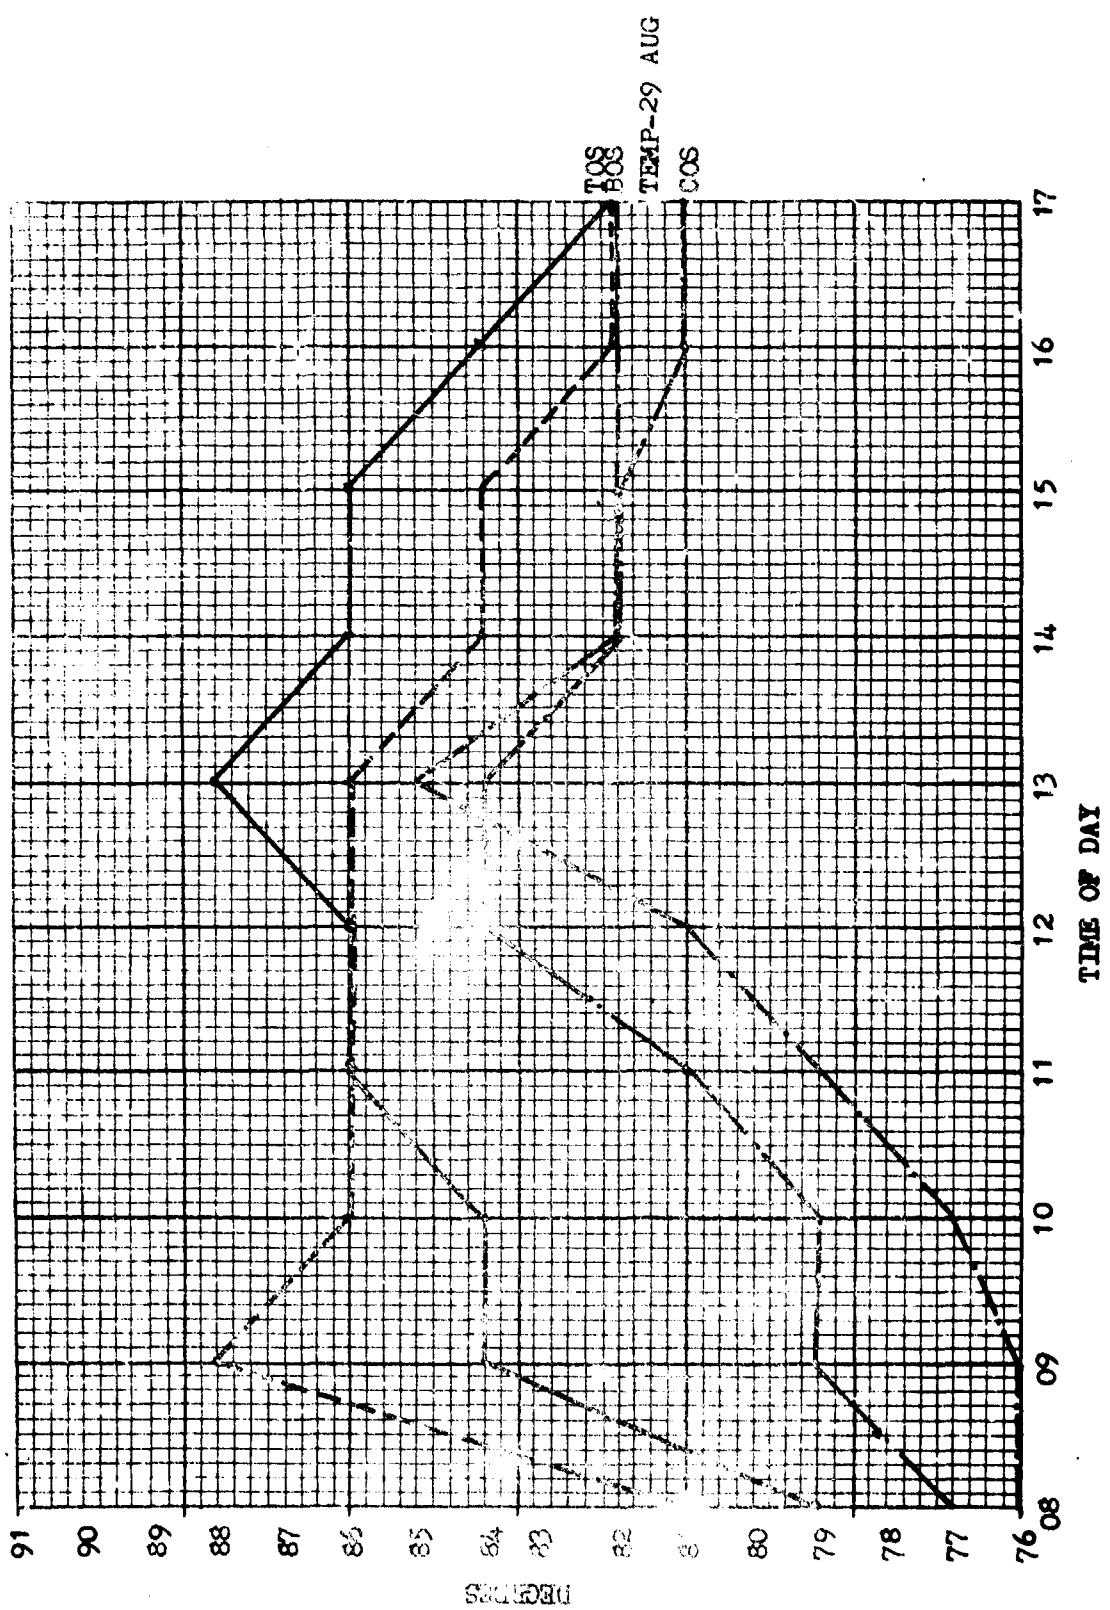
Ammunition Storage Area Temperatures, 28 Aug 66, TSN ASP

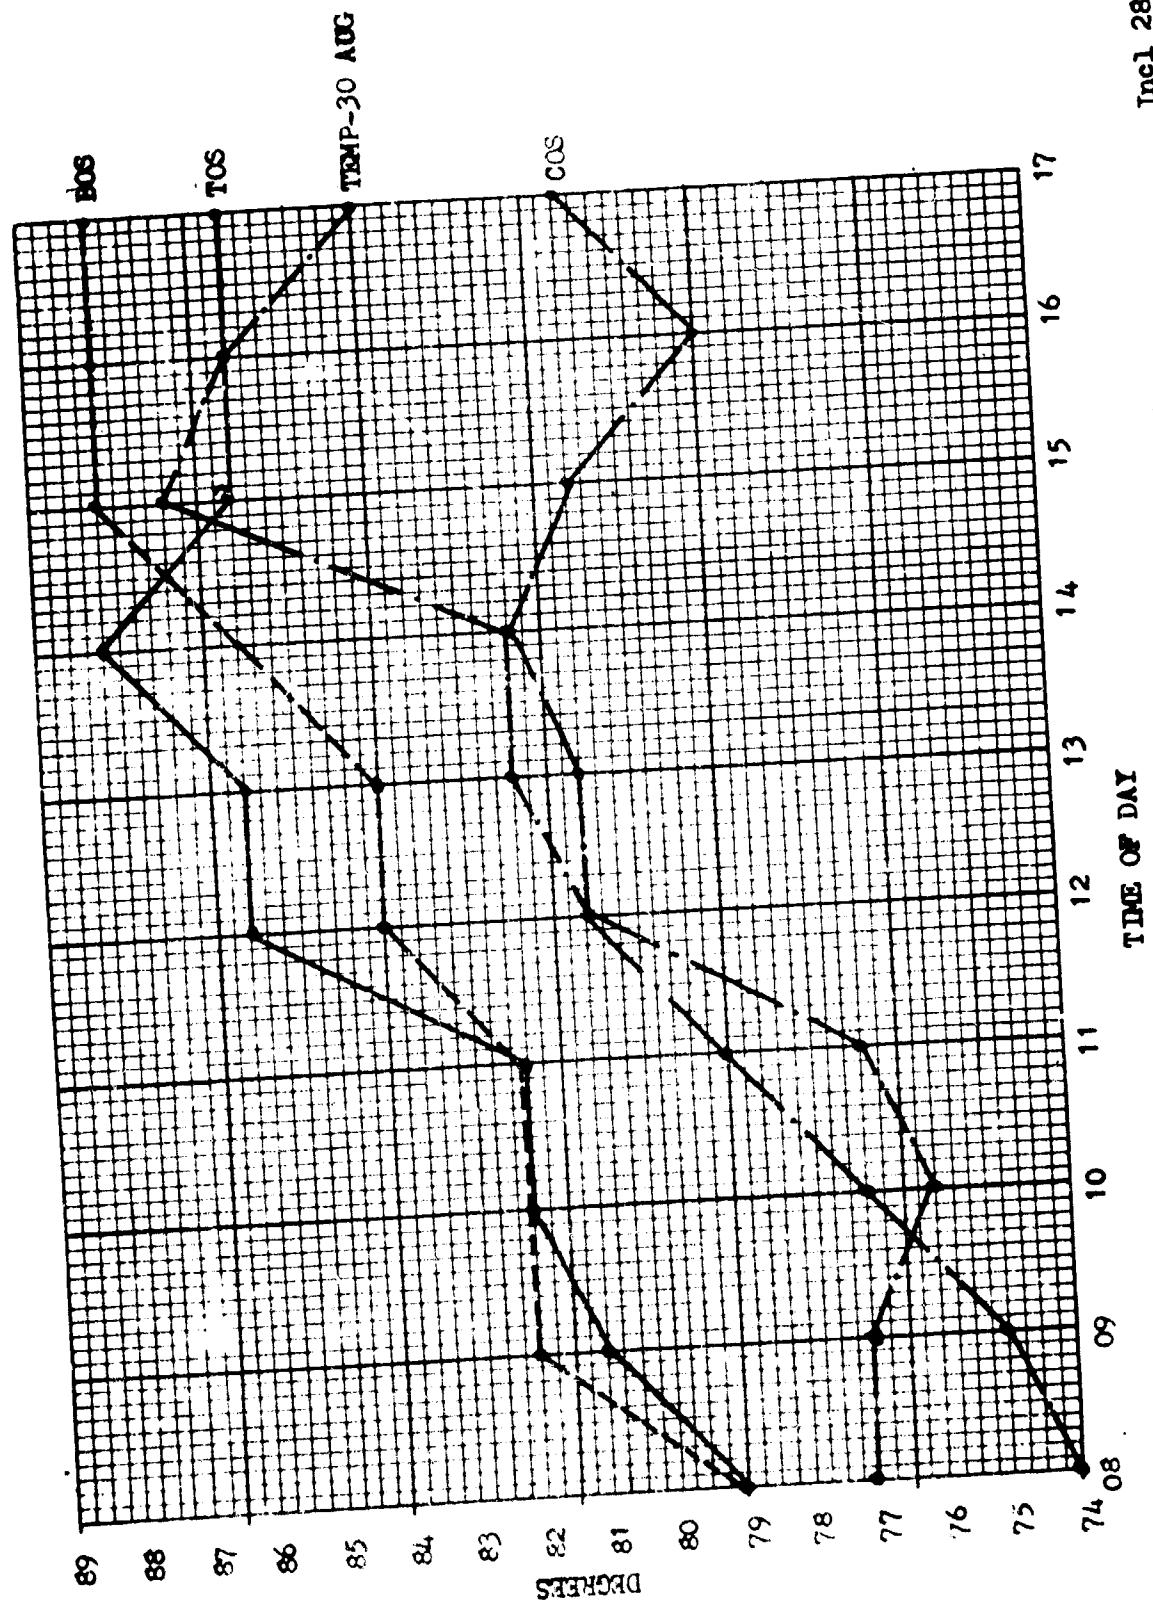
Ammunition Storage Area Temperatures, 29 Aug 66, TSN ASP

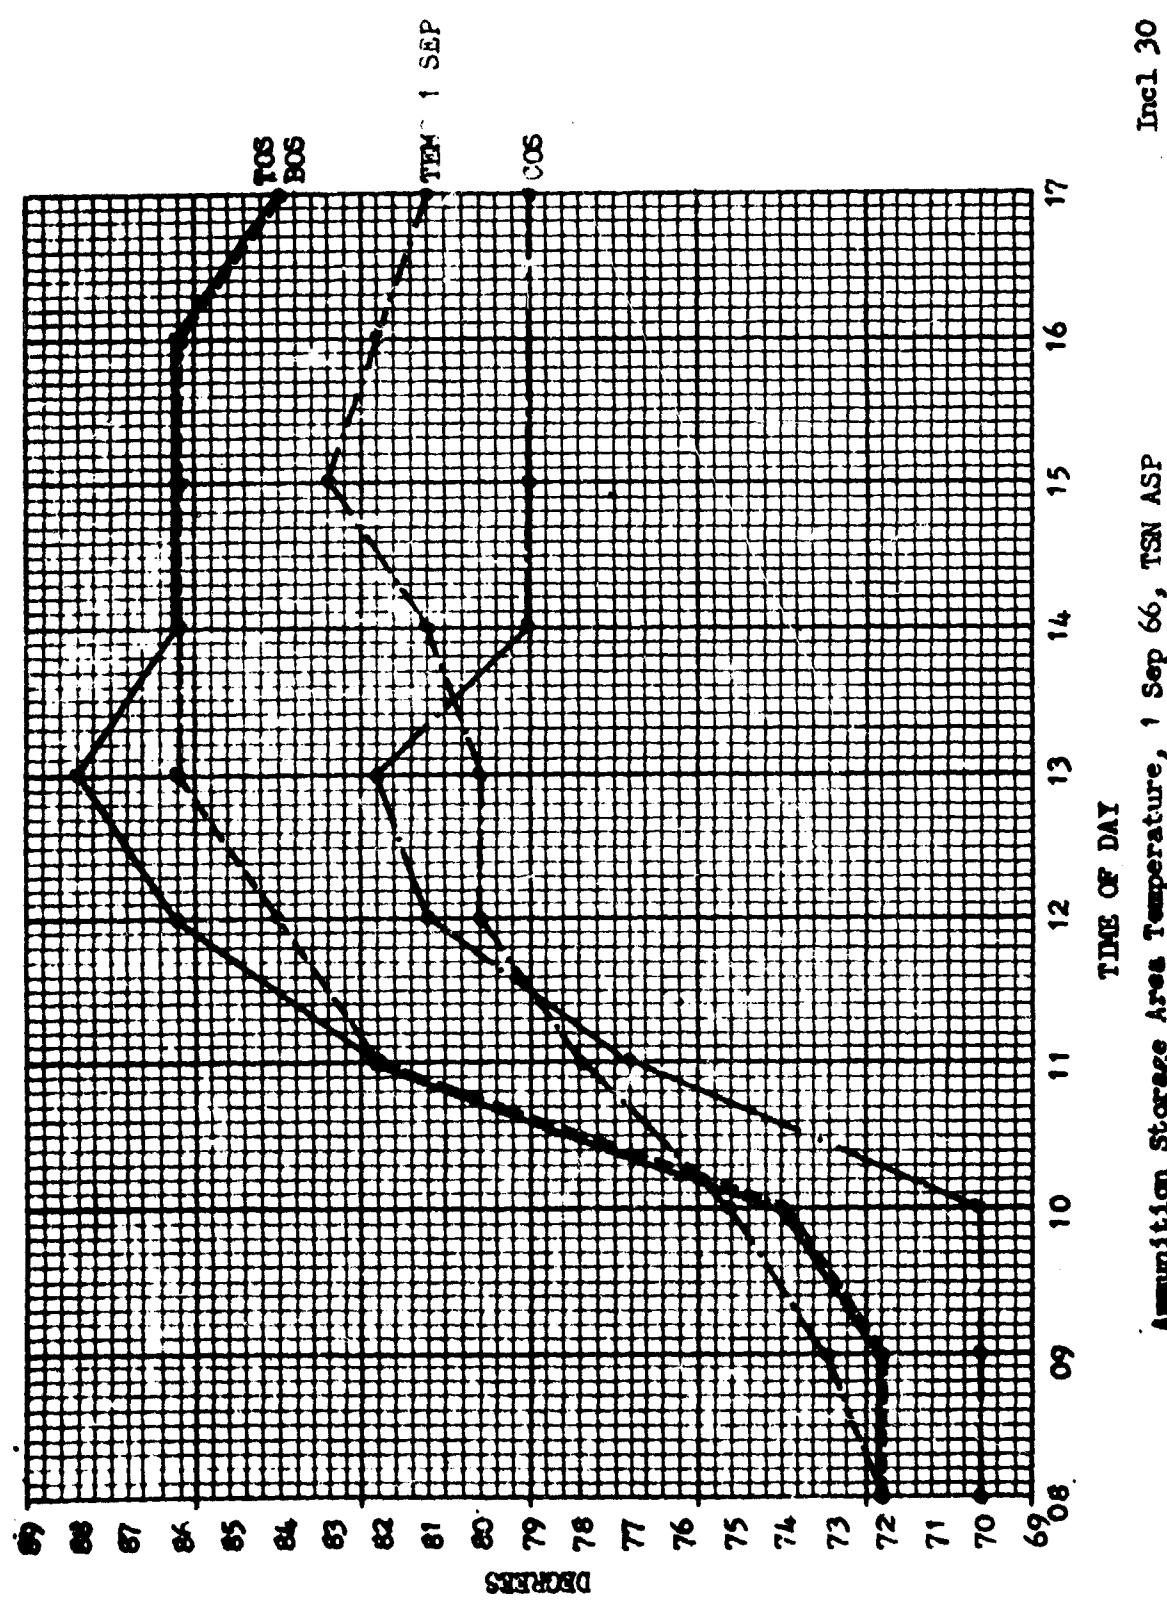
Ammunition Storage Area Temperatures, 31 Aug 66, TSM ASP

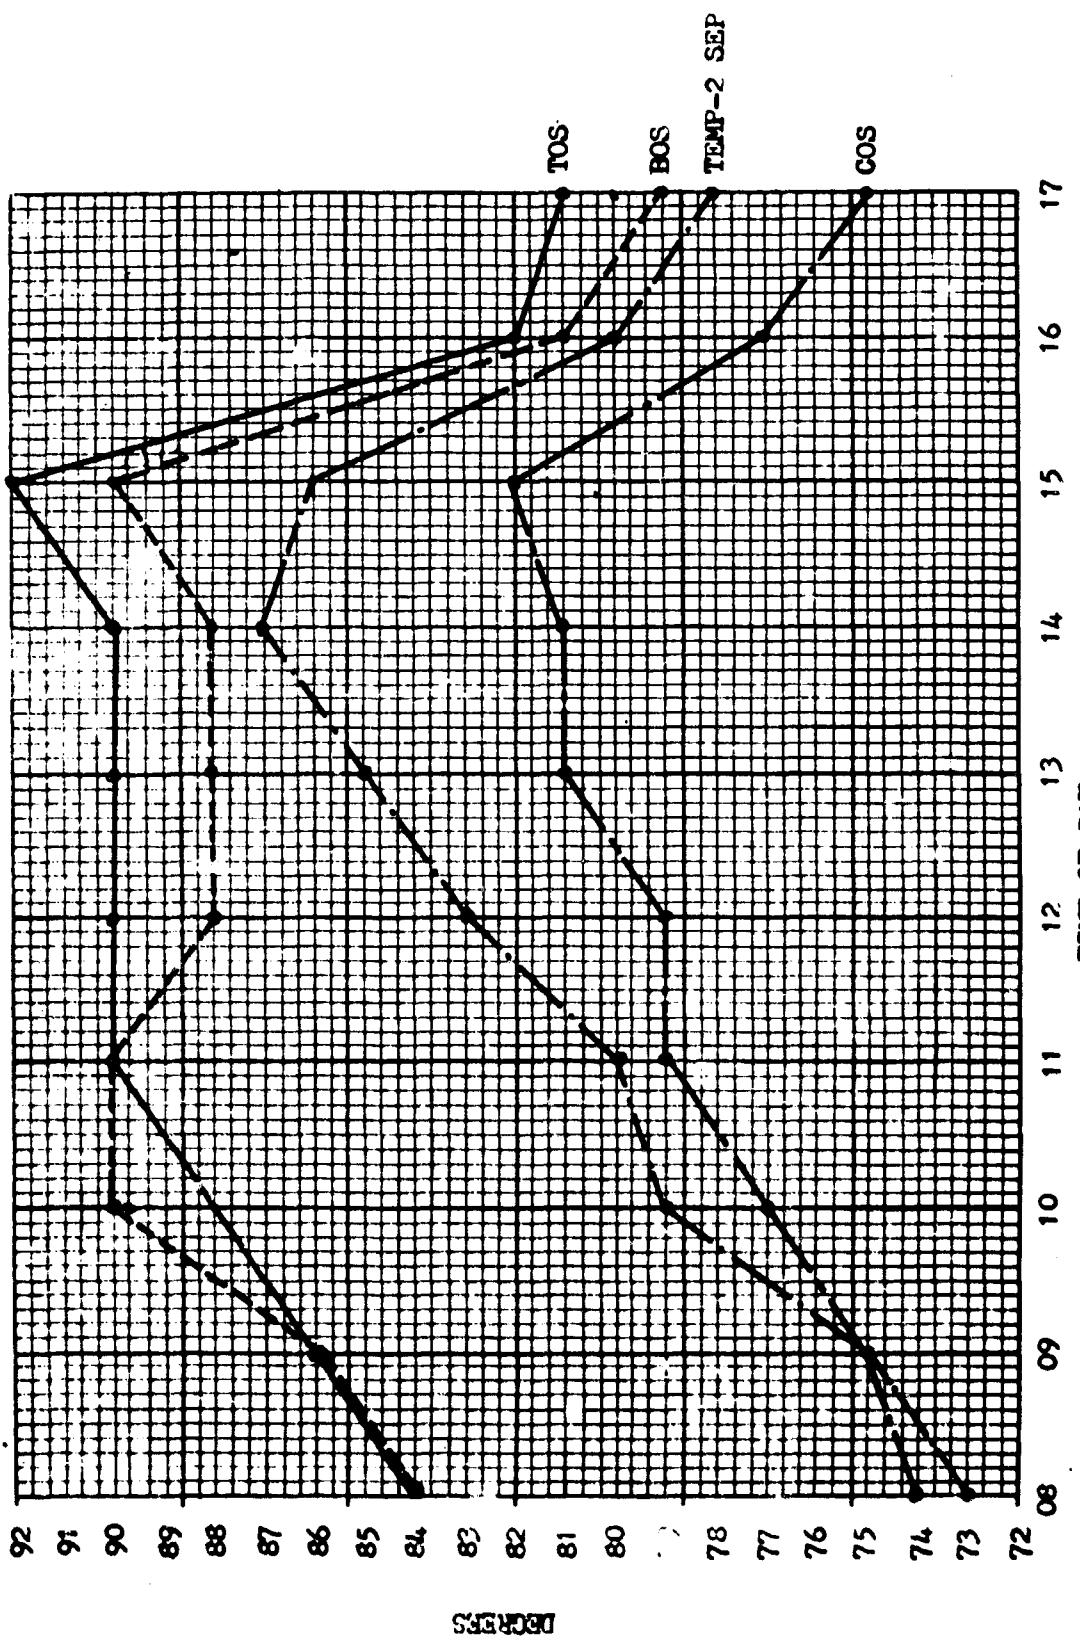
Ammunition Storage Area Temperature, 1 Sep 66, TSN ASP

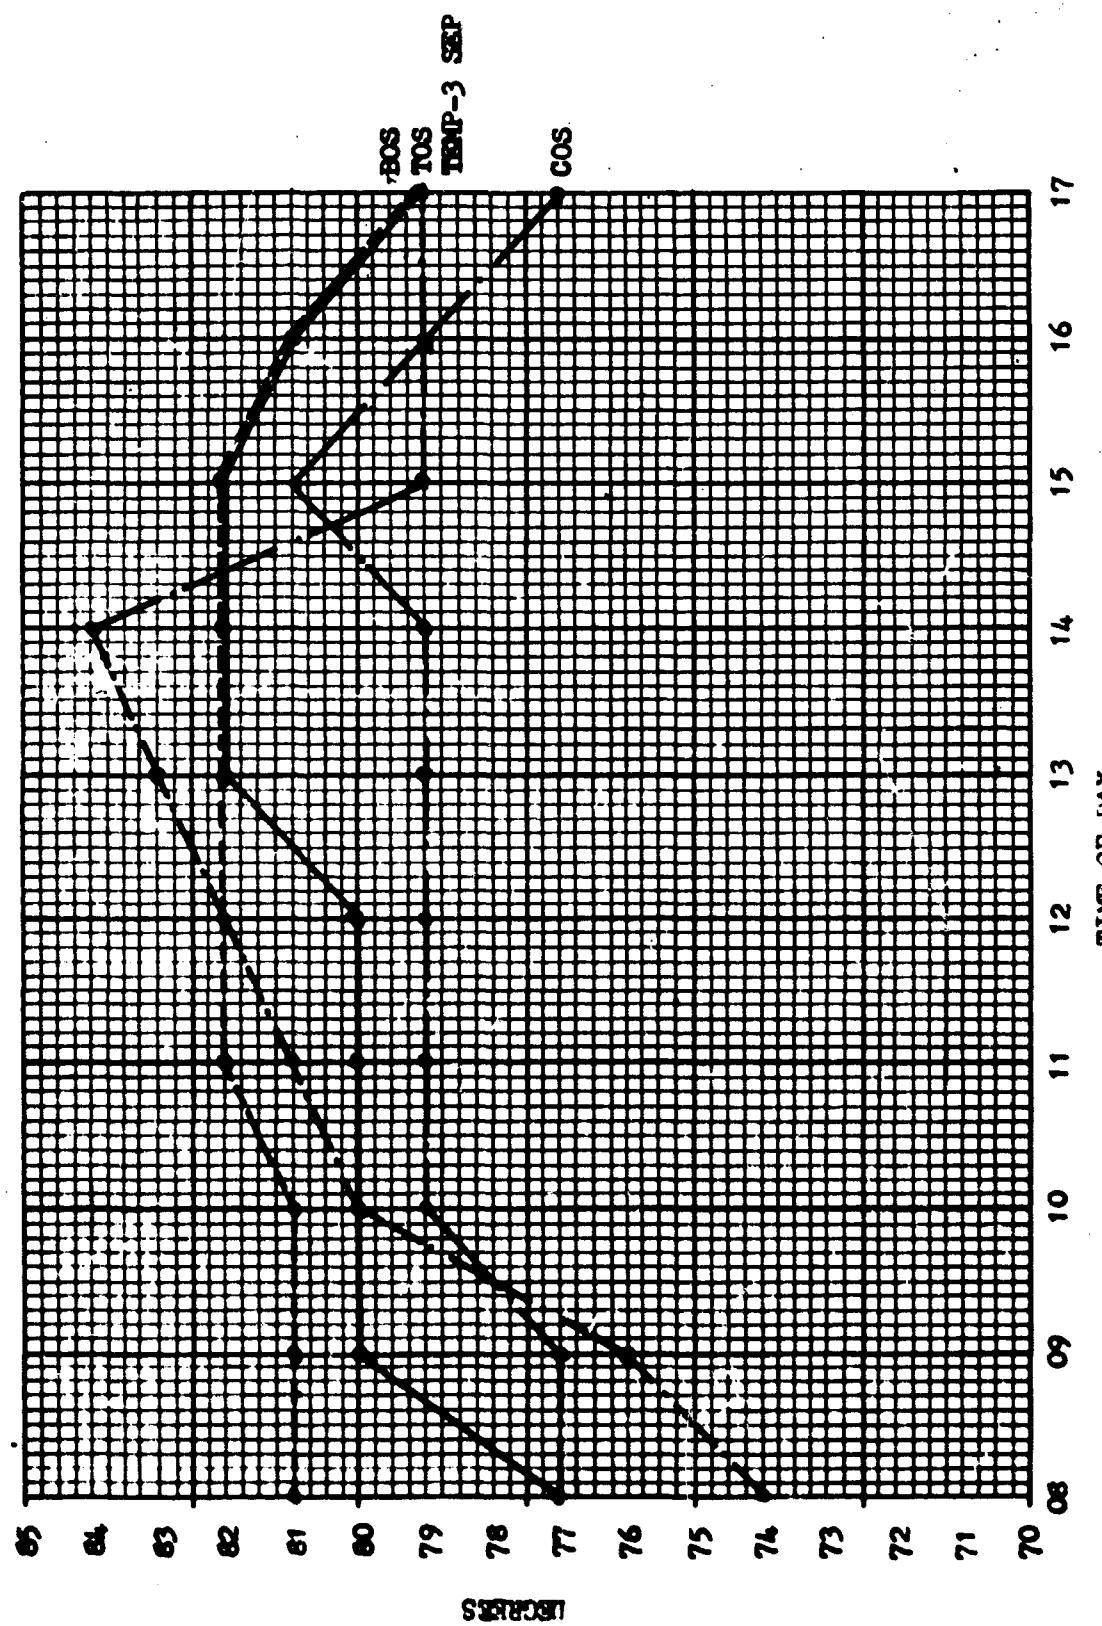
Ammunition Storage Area Temperatures, 2 Sep 66, TSN ASP

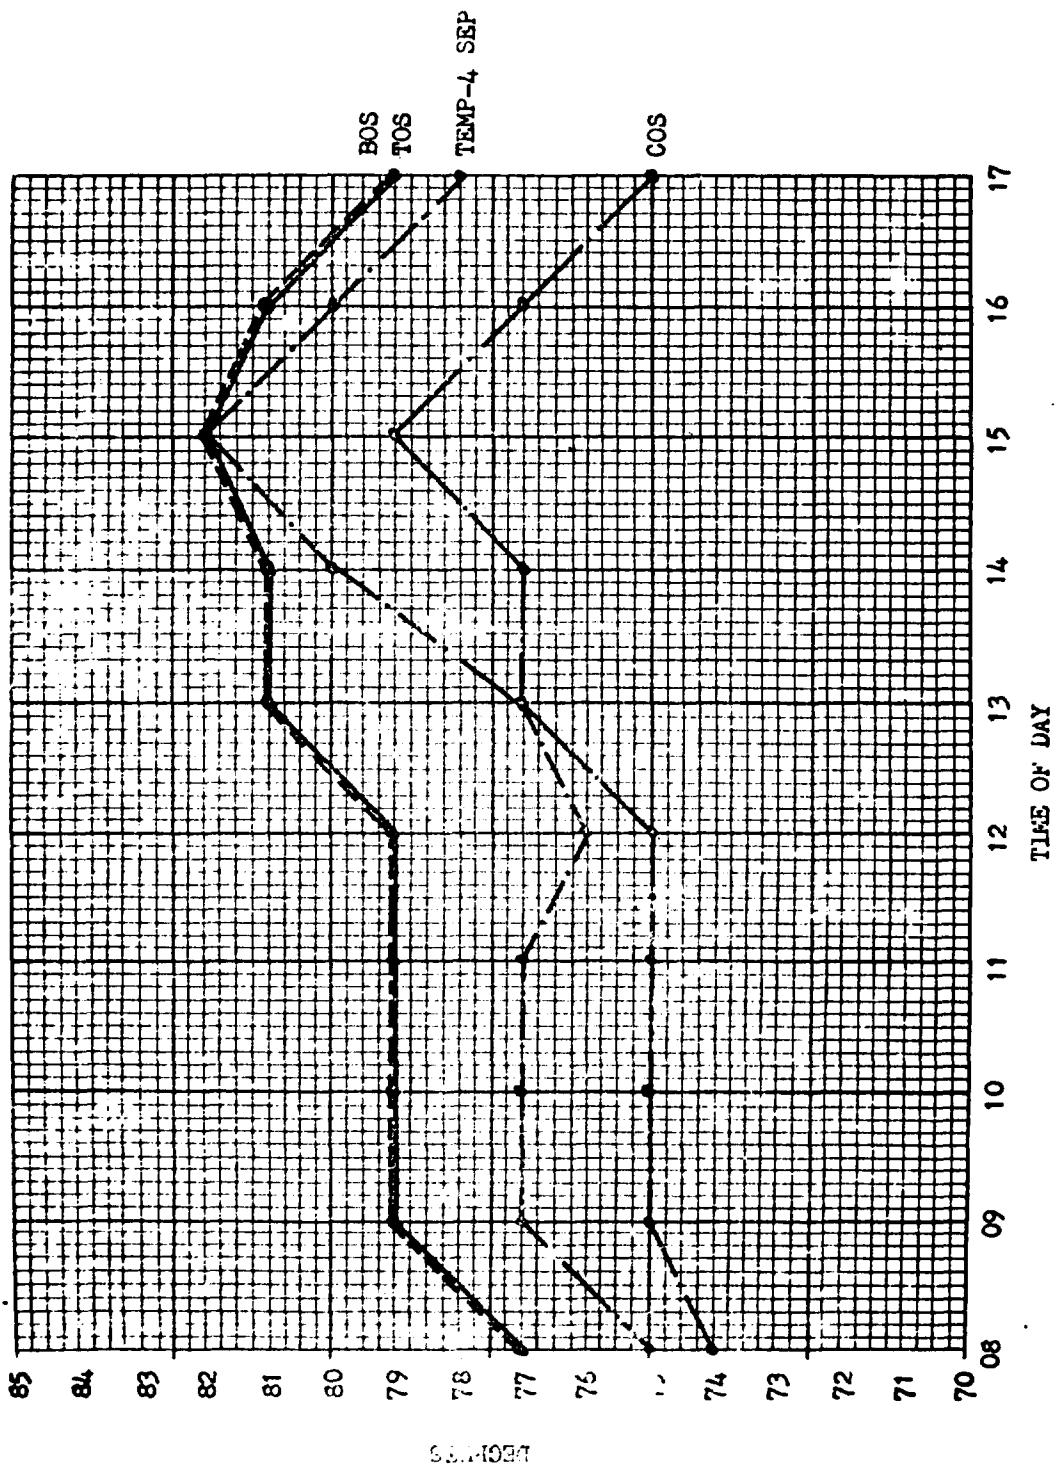
Ammunition Storage Area Temperatures, 3 Sep 66, TSM ASP

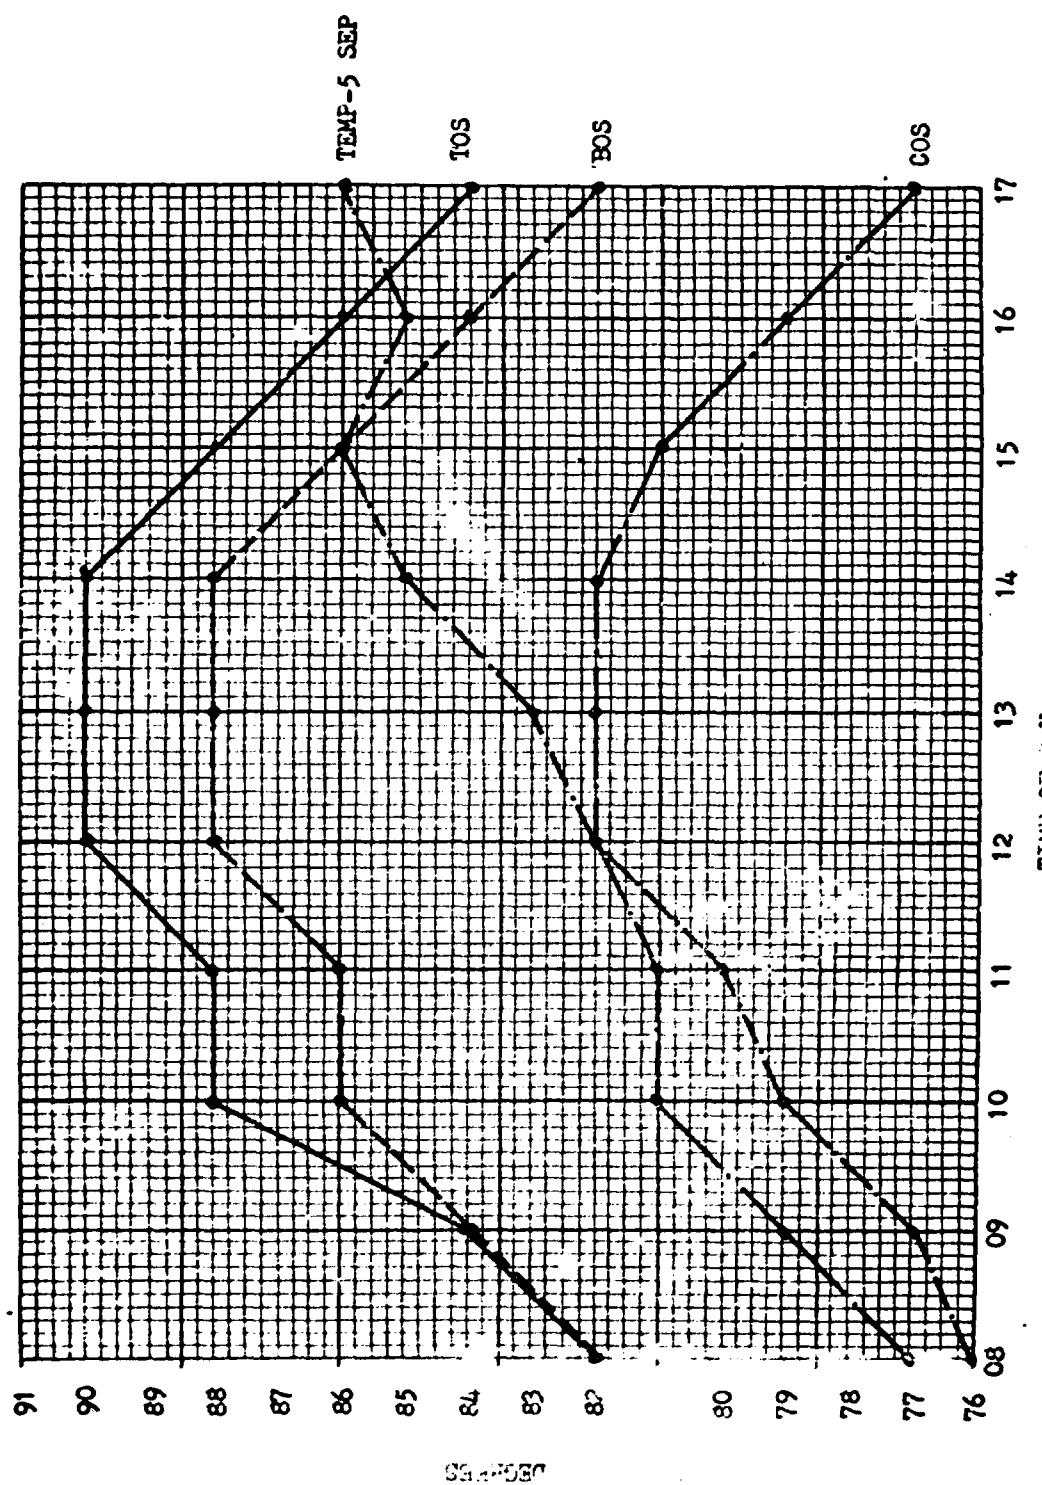
Ammunition Storage Area Temperatures, 4 Sep 66, TSN ASP
